RESEARCH MEMORANDUM

FACILITIES AND METHODS USED IN FULL-SCALE
AIRPLANE CRASH-FIRE INVESTIGATION

By Dugald O. Black

Lewis Flight Propulsion Laboratory
Cleveland, Ohio

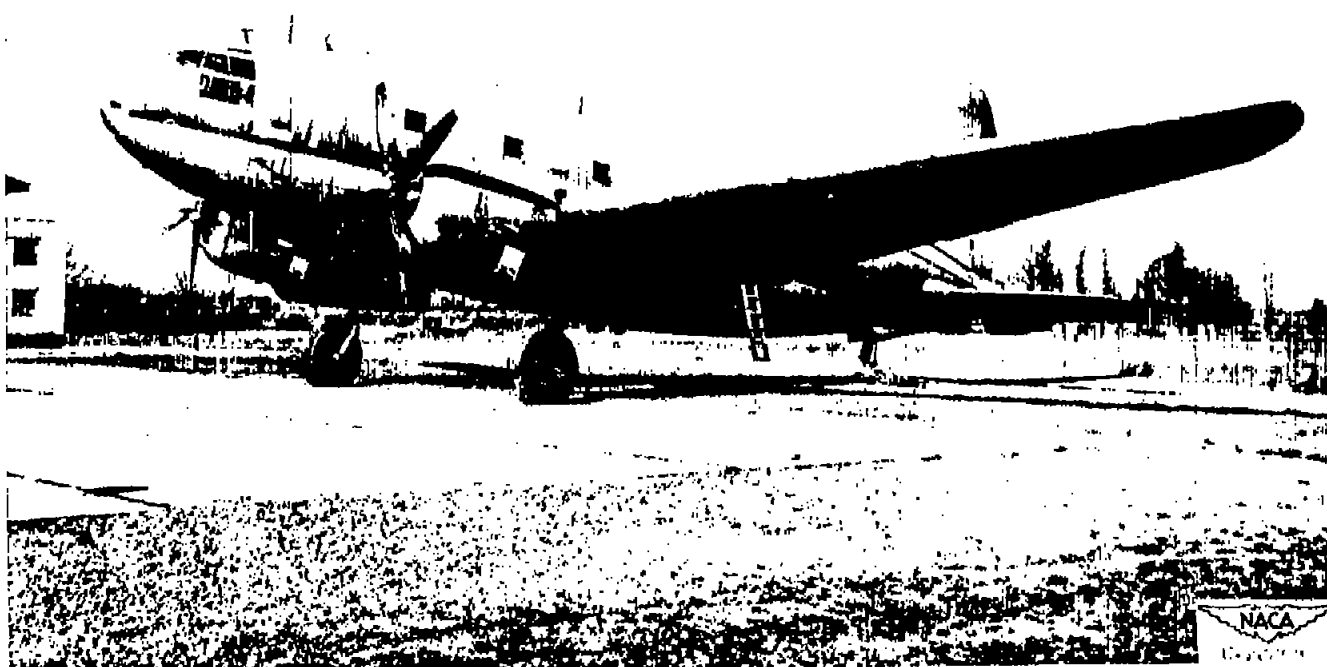
(a) C-46.

Figure 1. - Airplanes used in full-scale crash-fire investigation.

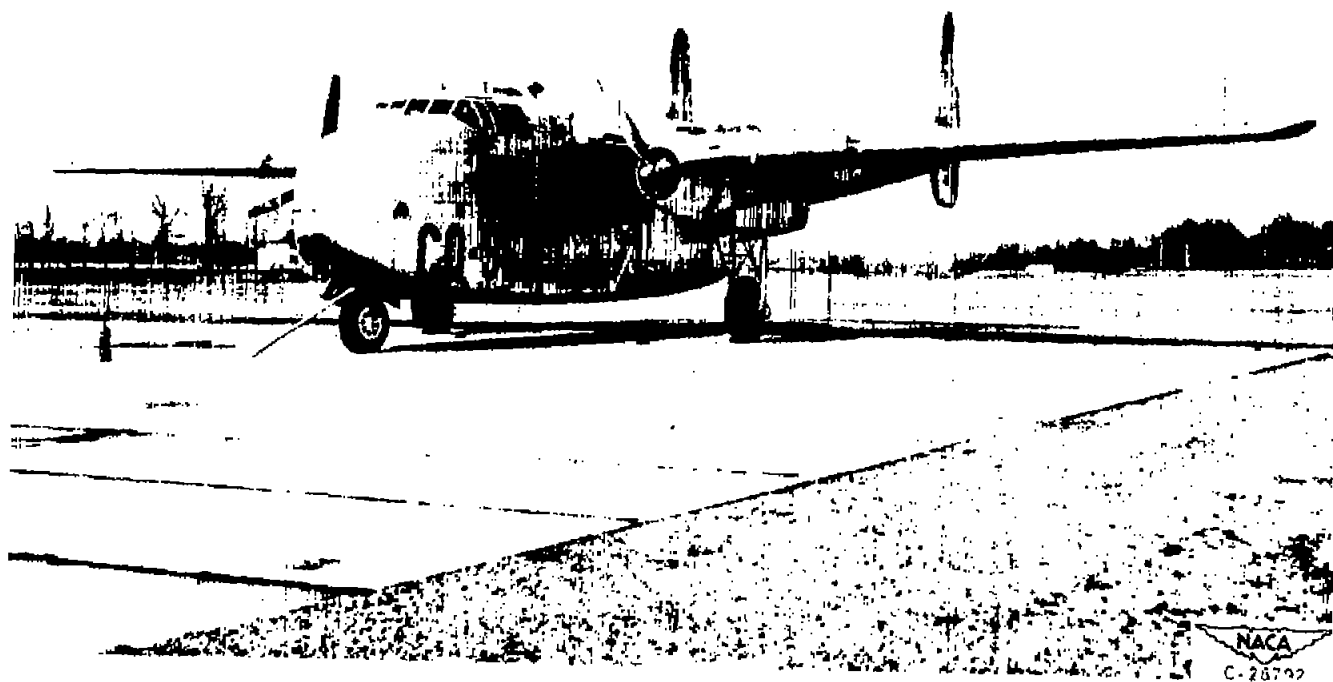
(b) C-82.

Figure 1. - Concluded. Airplanes used in full-scale crash-fire investigation.

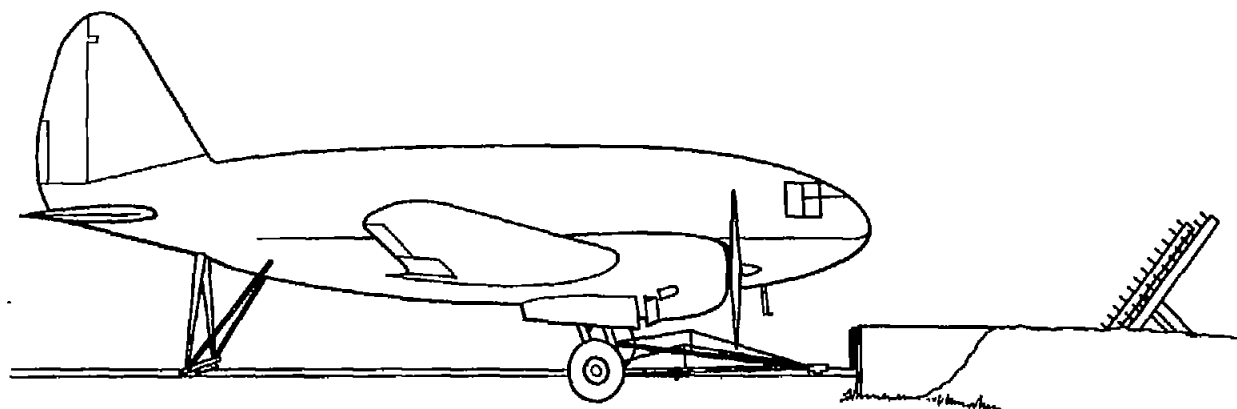
(a) Airplane approaching crash barrier.

Figure 2. - Schematic diagrams showing location of crash and pole barrier with respect to various components of C-46 airplane.

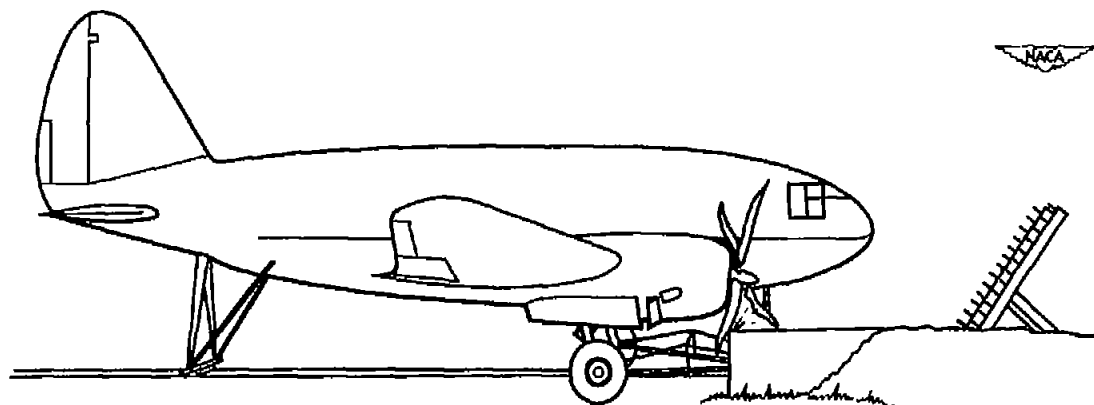
(b) Propeller strikes crash barrier.

Figure 2. - Continued. Schematic diagrams showing location of crash and pole barrier with respect to various components of C-46 airplane.

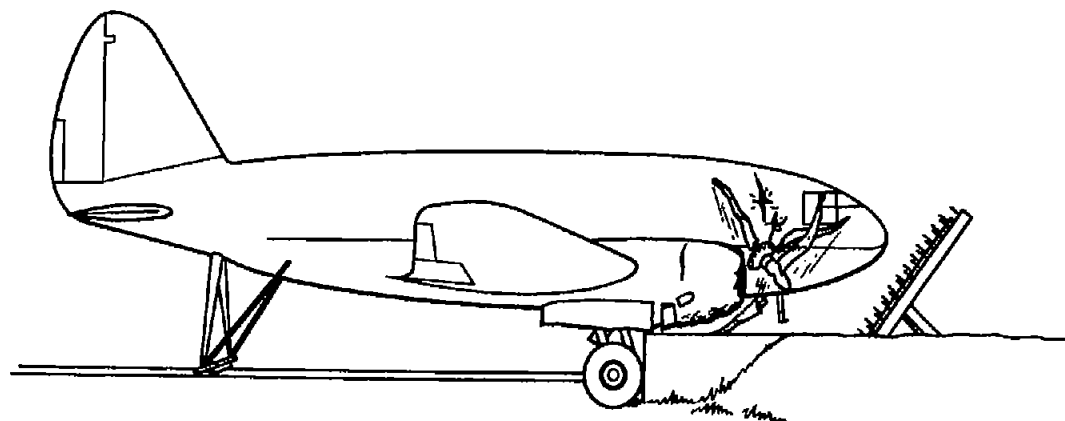
(c) Main landing gear strikes crash barrier.

Figure 2. - Continued. Schematic diagrams showing location of crash and pole barrier with respect to various components of C-46 airplane.

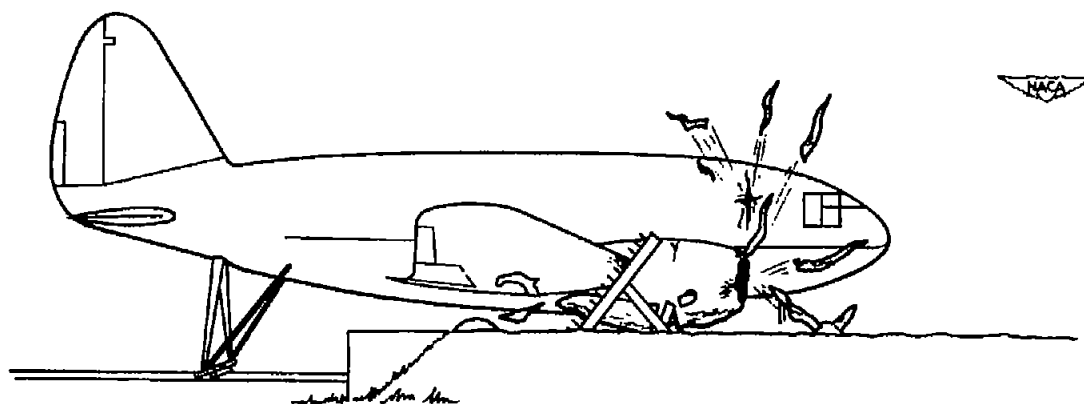
(d) Wings about to strike pole barrier.

Figure 2. - Concluded. Schematic diagrams showing location of crash and pole barrier with respect to various components of C-46 airplane.

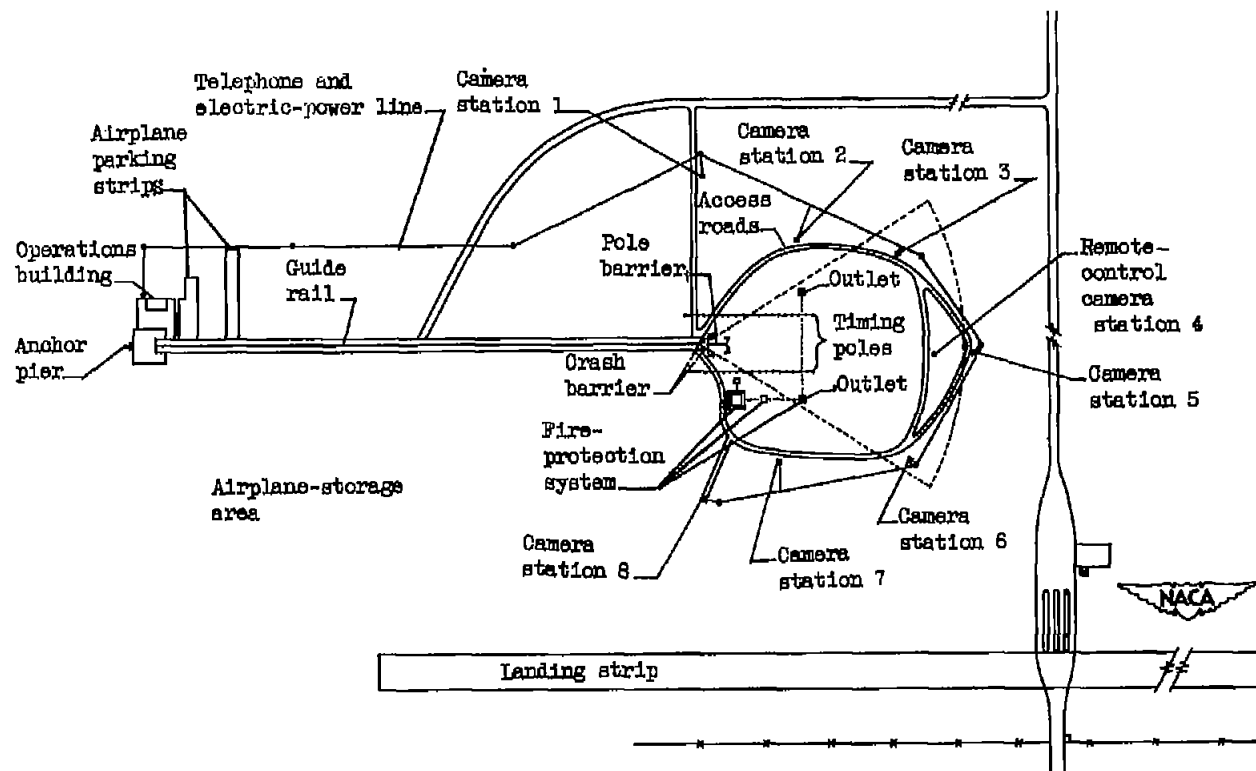
Figure 3. - Plan view of test site for conducting full-scale crash-fire investigation.

Camera platforms, from which motion pictures of the crash were recorded, were located at seven places around the crash area (fig. 3). Each platform was constructed of steel framework and armour plate for protection against flying debris (fig. 18). The height above the ground varied with each platform according to the requirements imposed by the terrain of the crash area.

Mitchell, Ciné, Fastax, and K-24 cameras, all operated electrically, were used in this investigation. Three Mitchell motion-picture cameras were located on the camera platforms at stations 2, 5, and 7 (see fig. 3). They operated without interruption throughout the crash and were loaded with a 1200-foot reel of 16 millimeter color film. These cameras operated at 128 frames per second as the airplane approached the crash barrier, through the subsequent crash, and slide to rest. The speed was then reduced to 48 frames per second for the remainder of the time. Only the Mitchell cameras were capable of taking motion pictures continuously throughout the crash and ensuing fire.

Two Ciné cameras were installed on camera platforms at stations 3 and 6 (see fig. 3). They were equipped with a 200-foot roll of 16 millimeter color film and operated at 24 frames per second. These two cameras were installed primarily as a precautionary measure in case of failure of the Mitchell cameras.

The Fastax high-speed motion-picture cameras were installed on the camera platforms at stations 1, 4, and 8 (see fig. 3). The camera installed at station 4 was remotely controlled by the operator in station 5. These cameras operated at speeds of from 100 to 1000 frames per second with either 16 millimeter black and white or high-speed color film. The speed and type of film used depended upon light conditions during the test. The film from Fastax cameras was studied to obtain information concerning the actual breakup of the airplane.

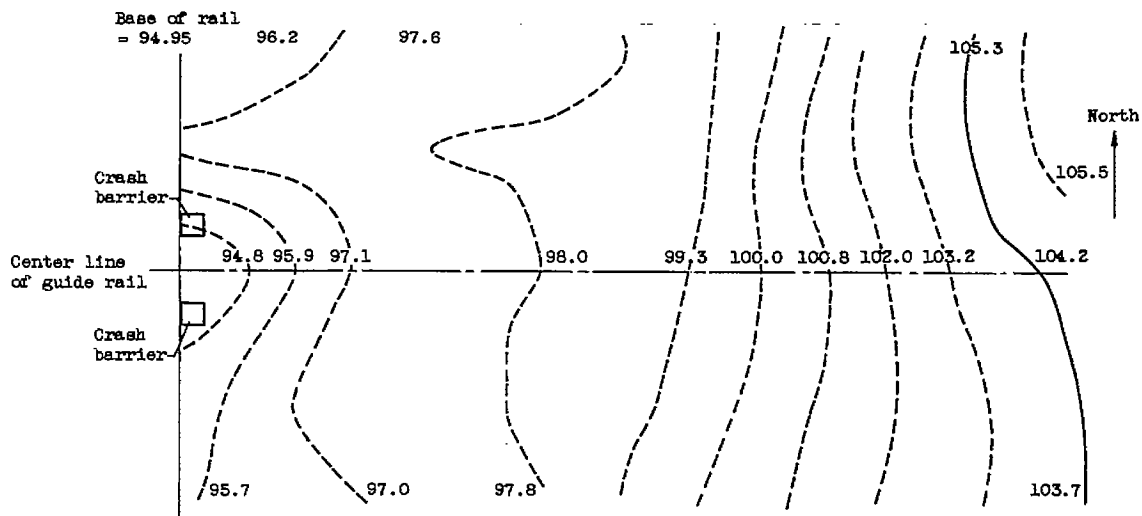
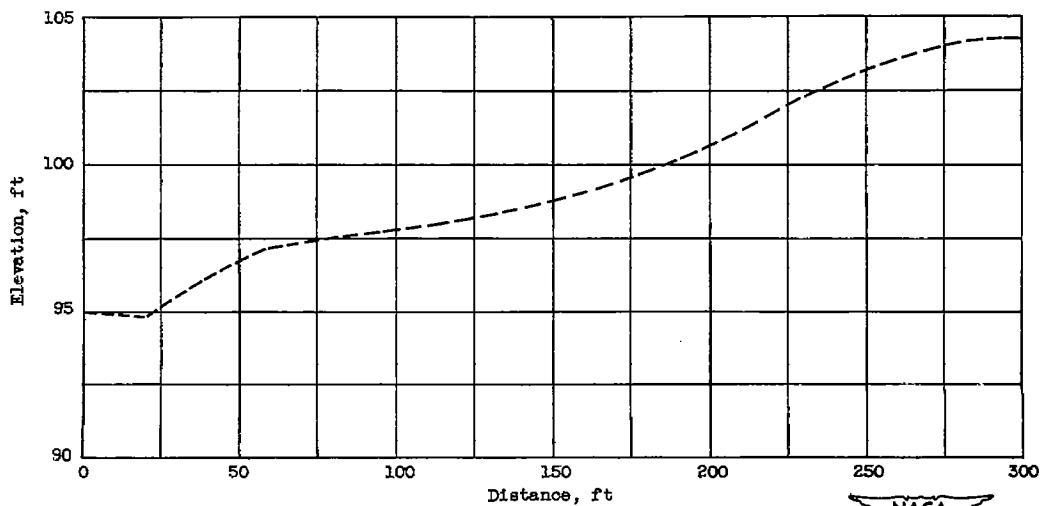
(a) Plan view.

(b) Profile view.

Figure 4. - Crash area in which the crash-fire investigation was conducted.

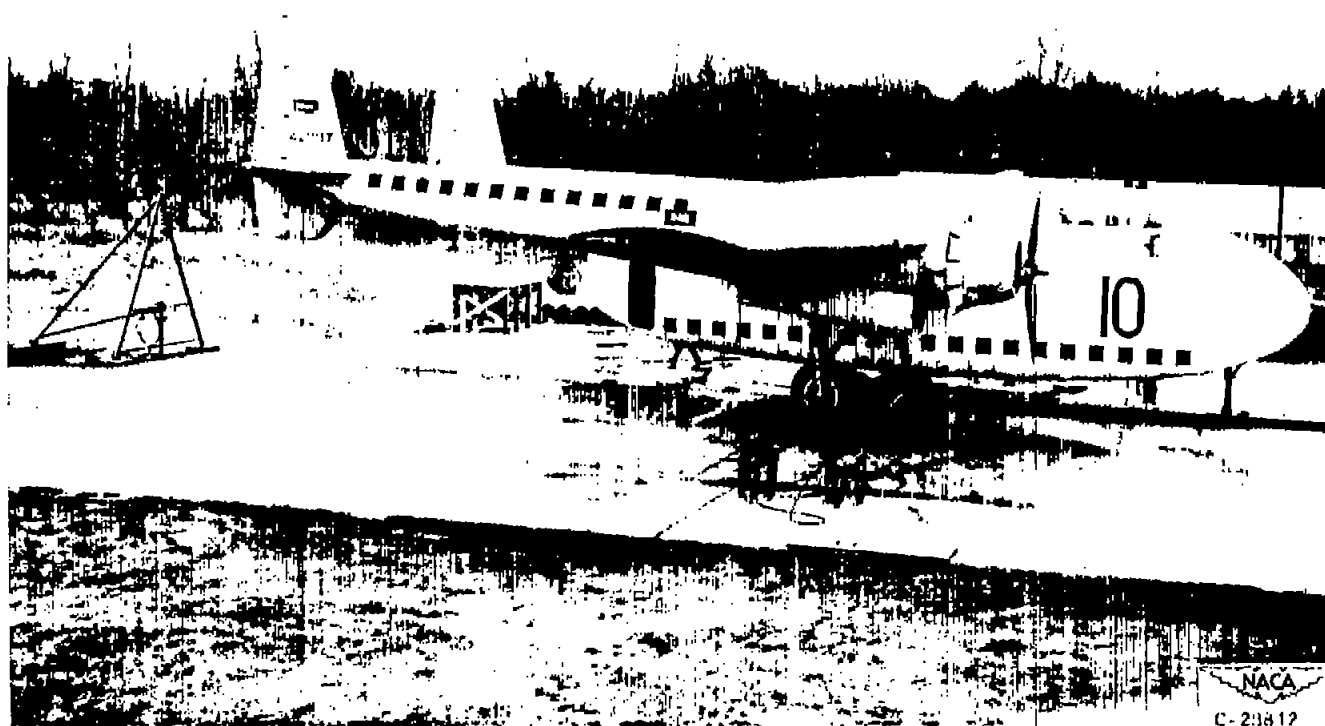
(a) Side view.

Figure 5. - C-82 Airplane being readied in preparation area for test.

(b) Front view.

Figure 5. - Concluded. C-82 airplane being readied in preparation area for test.

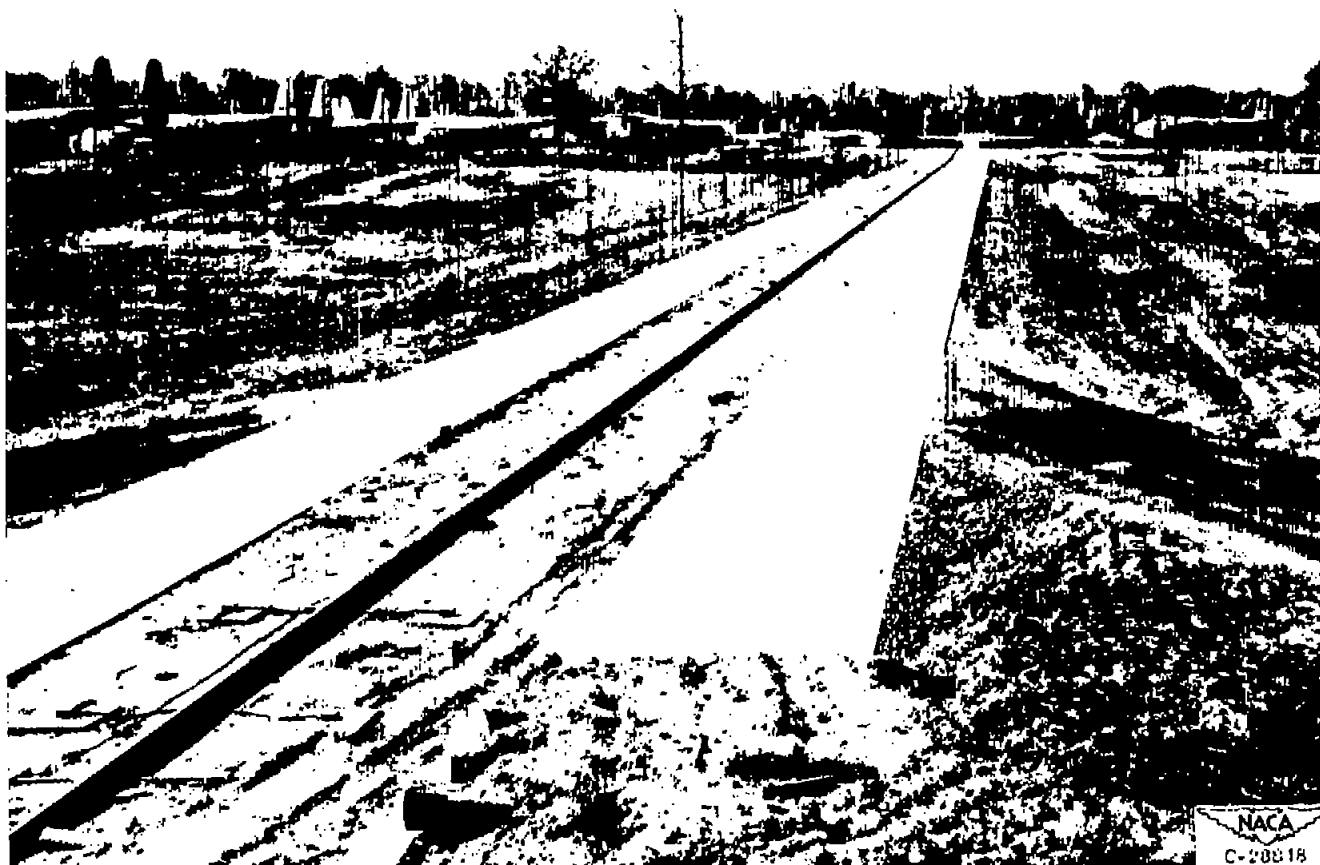
NACA
C-28818

Figure 6. - Runway and center rail for guiding airplanes to crash barrier.

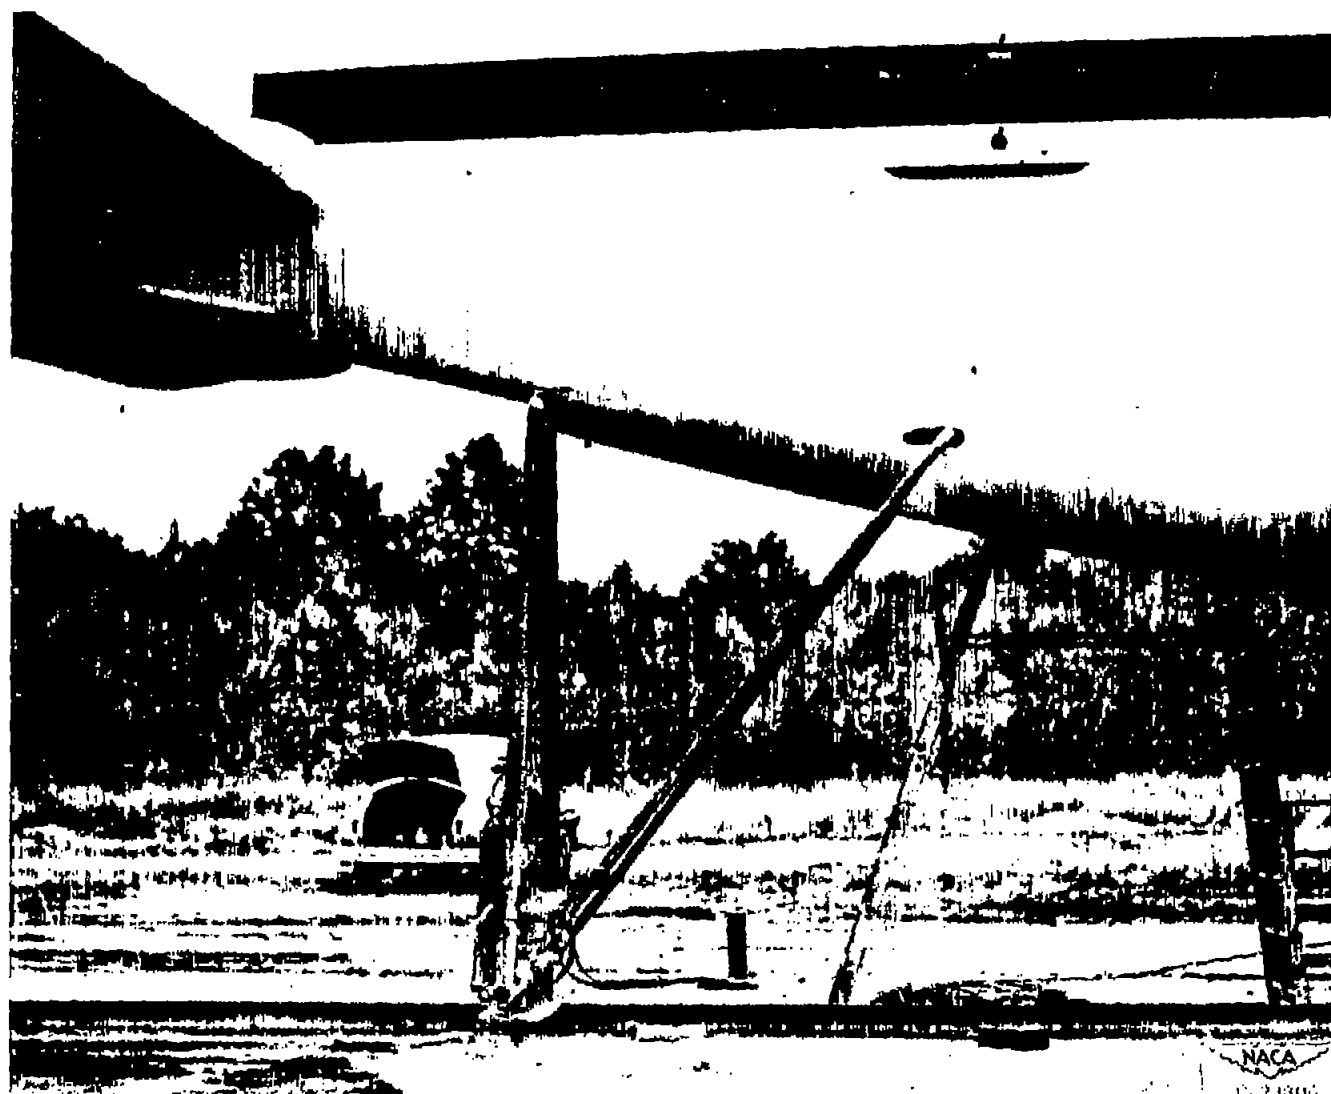
Figure 8. - Extended tail-truss support for holding C-46 airplane in flight attitude.

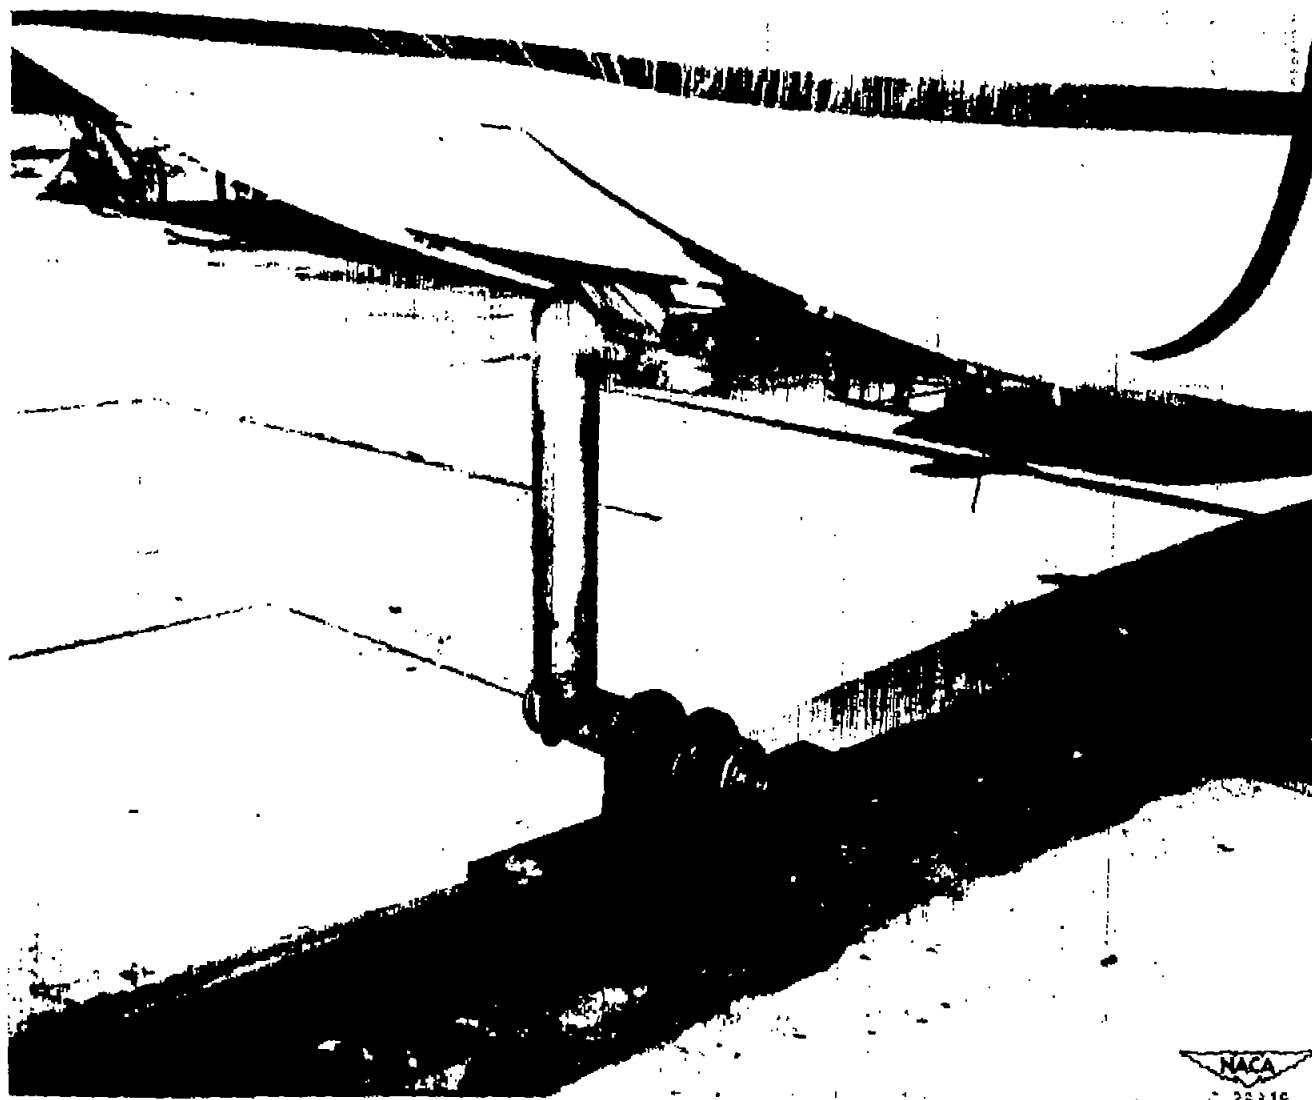
Figure 9. - Guide slipper attached to nose-gear axle of C-82 airplane.

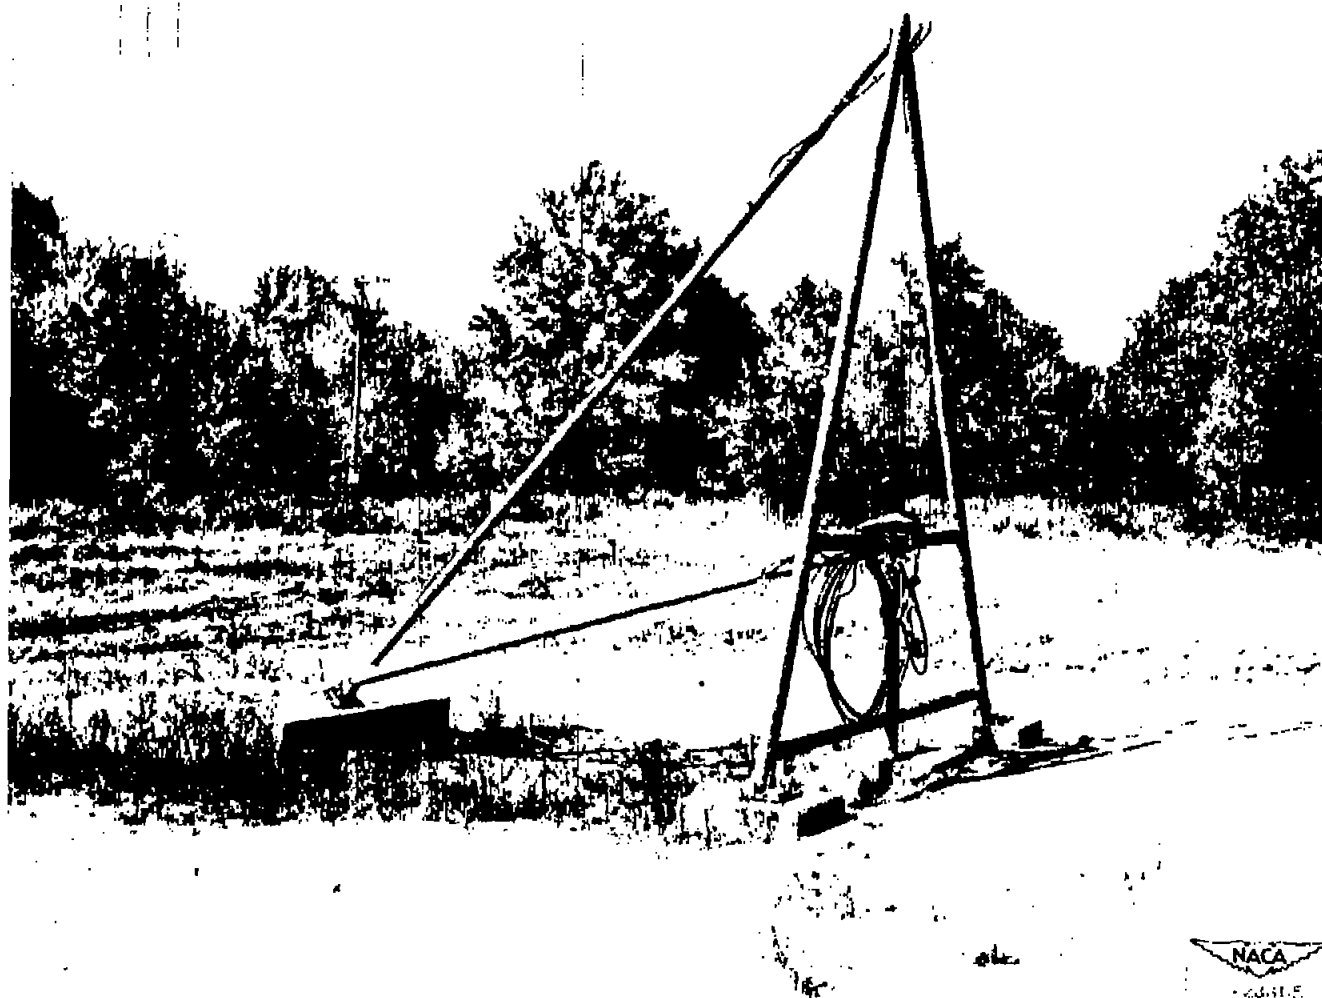
Figure 10. - Anchor pier for retaining airplane before release.

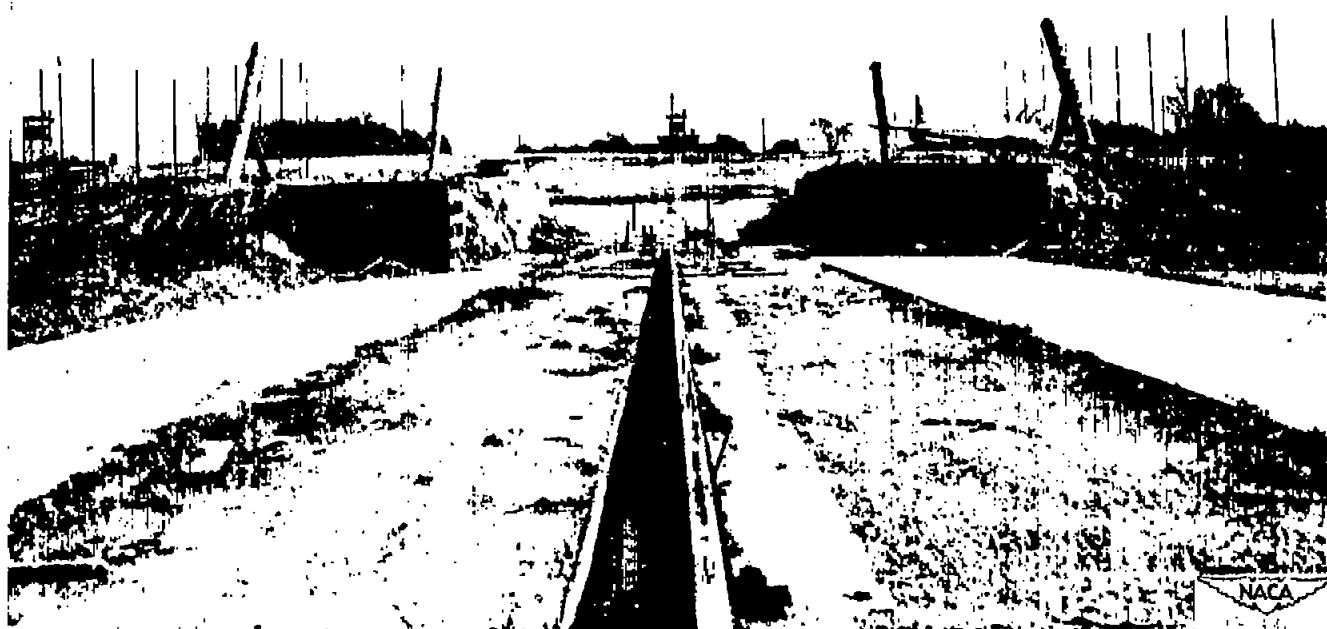
(b) For C-82 airplanes.

Figure 11. - Concluded. Crash and pole barriers.

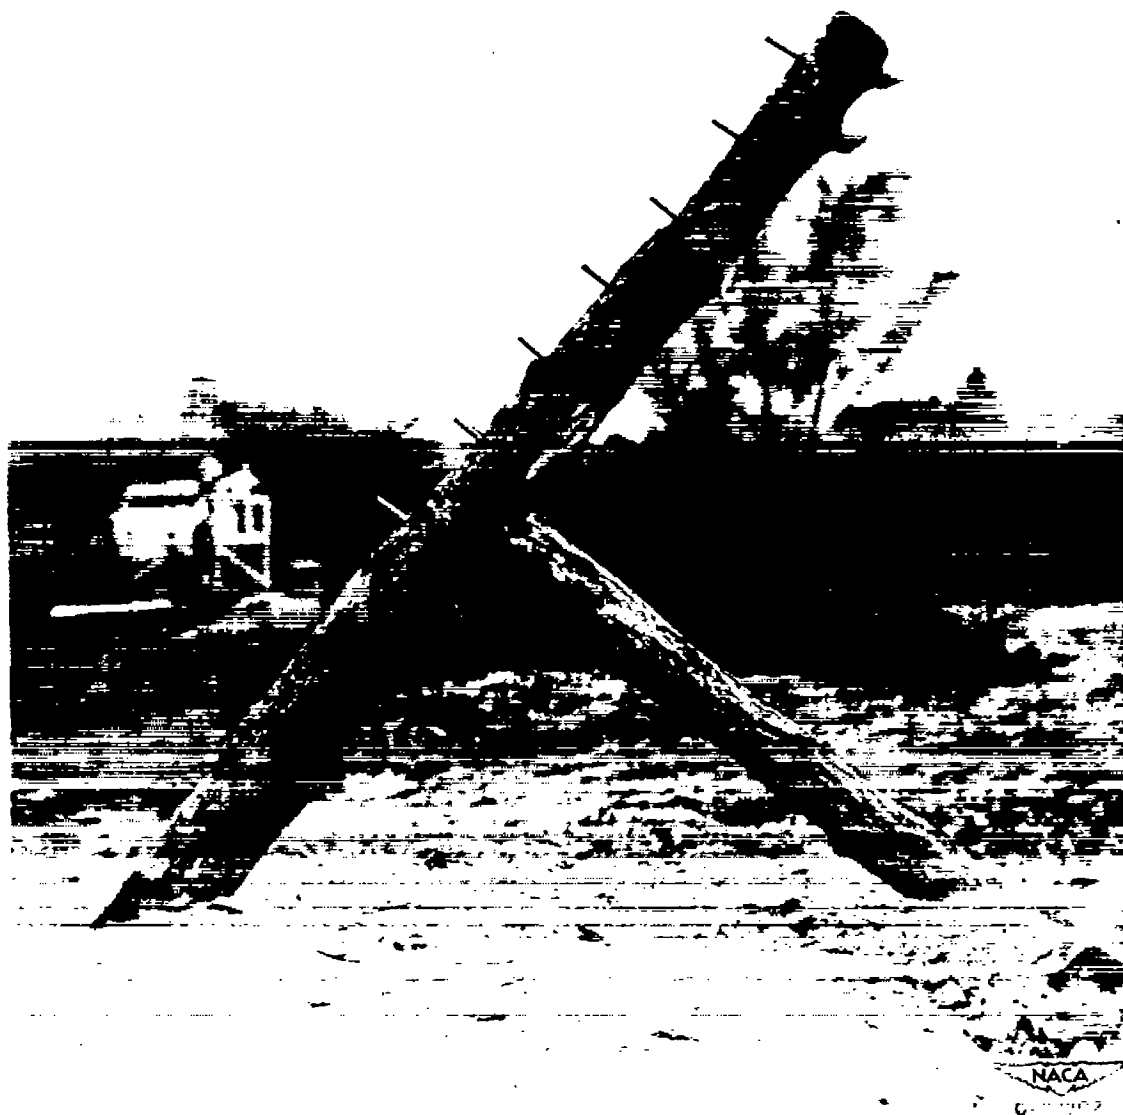
Figure 12. - Close-up of pole barrier showing steel spikes.

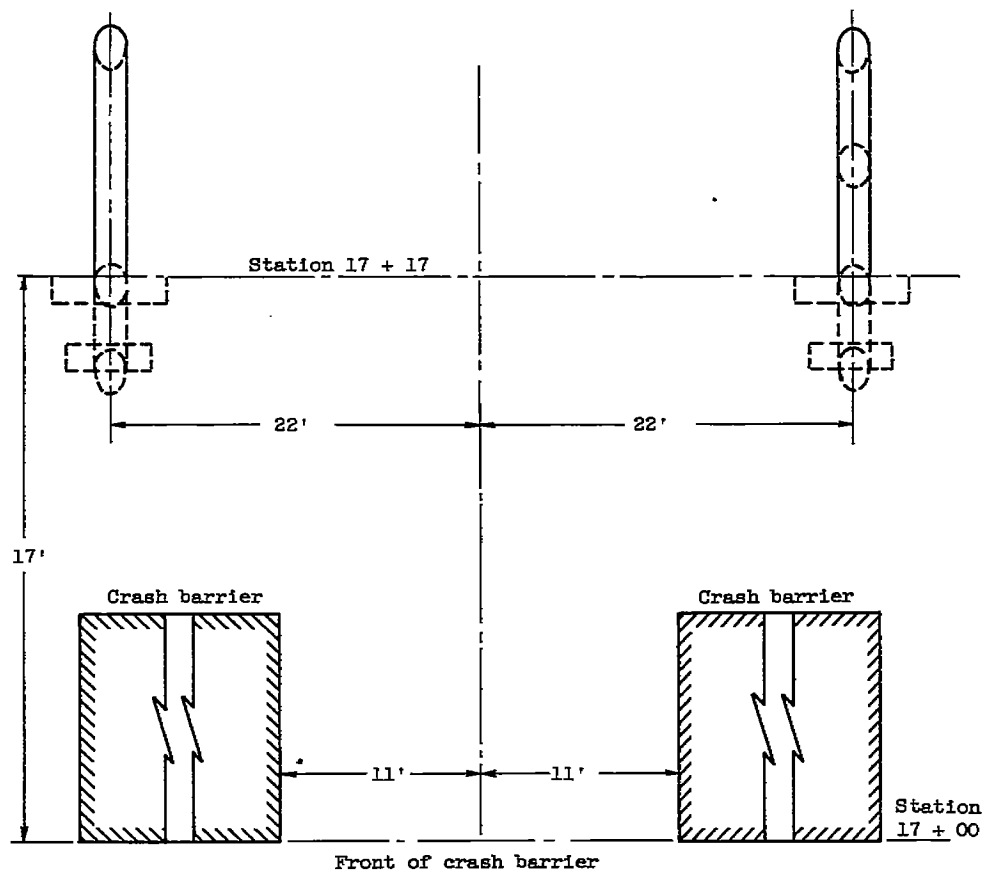
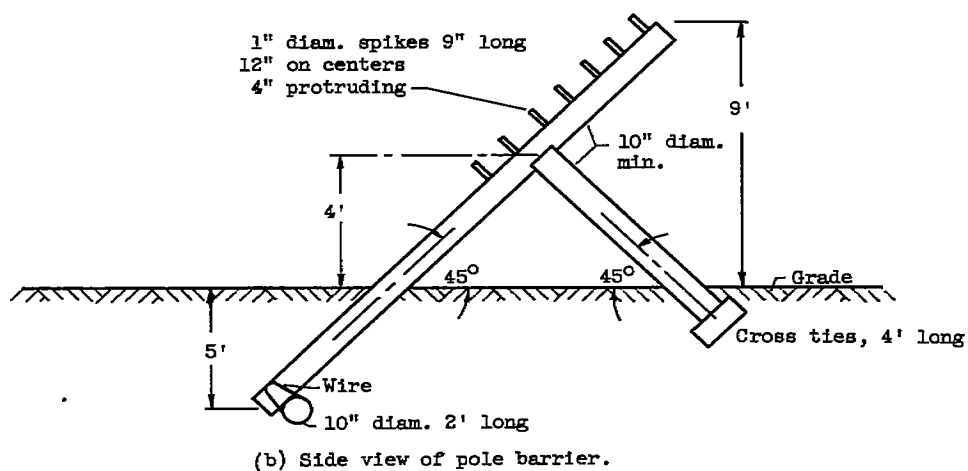
(a) Plan view of crash barrier.

Figure 13. - Sketch showing location of pole barrier for C-46 airplane crash tests.

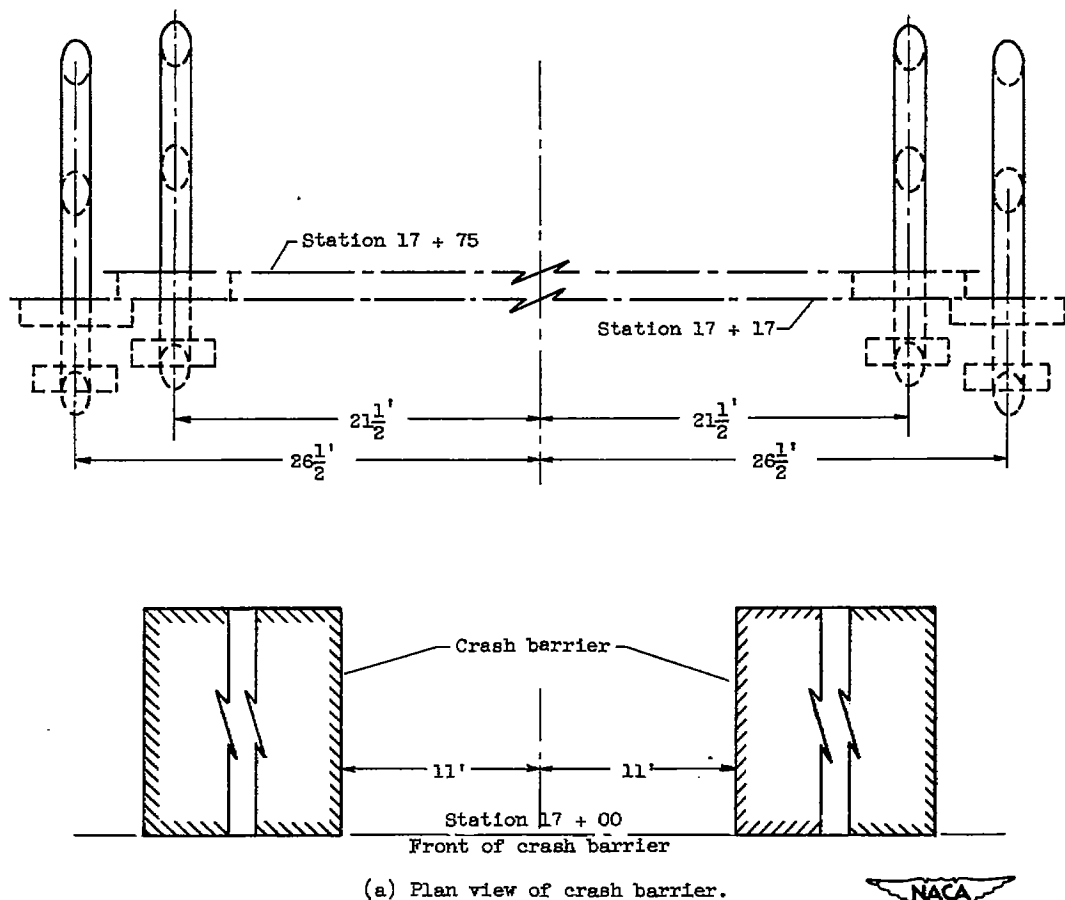
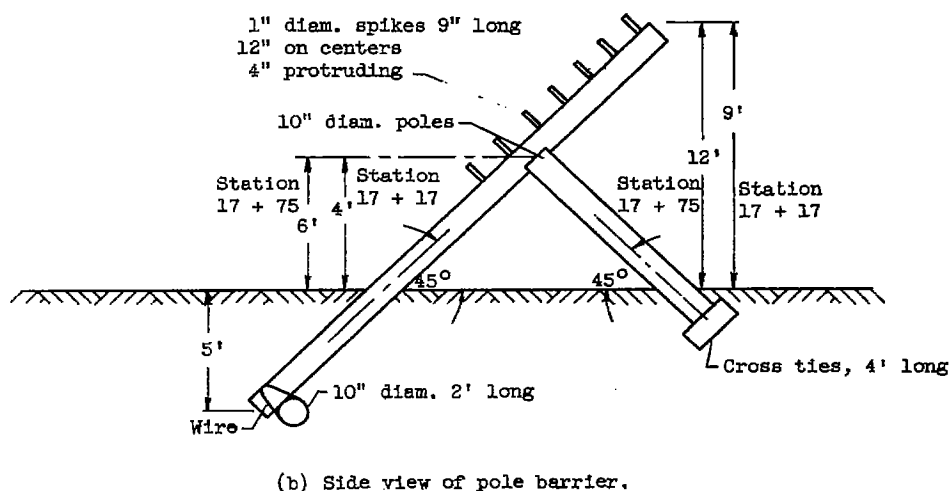
Figure 14. - Sketch showing location of pole barrier for C-32 airplane crash tests.

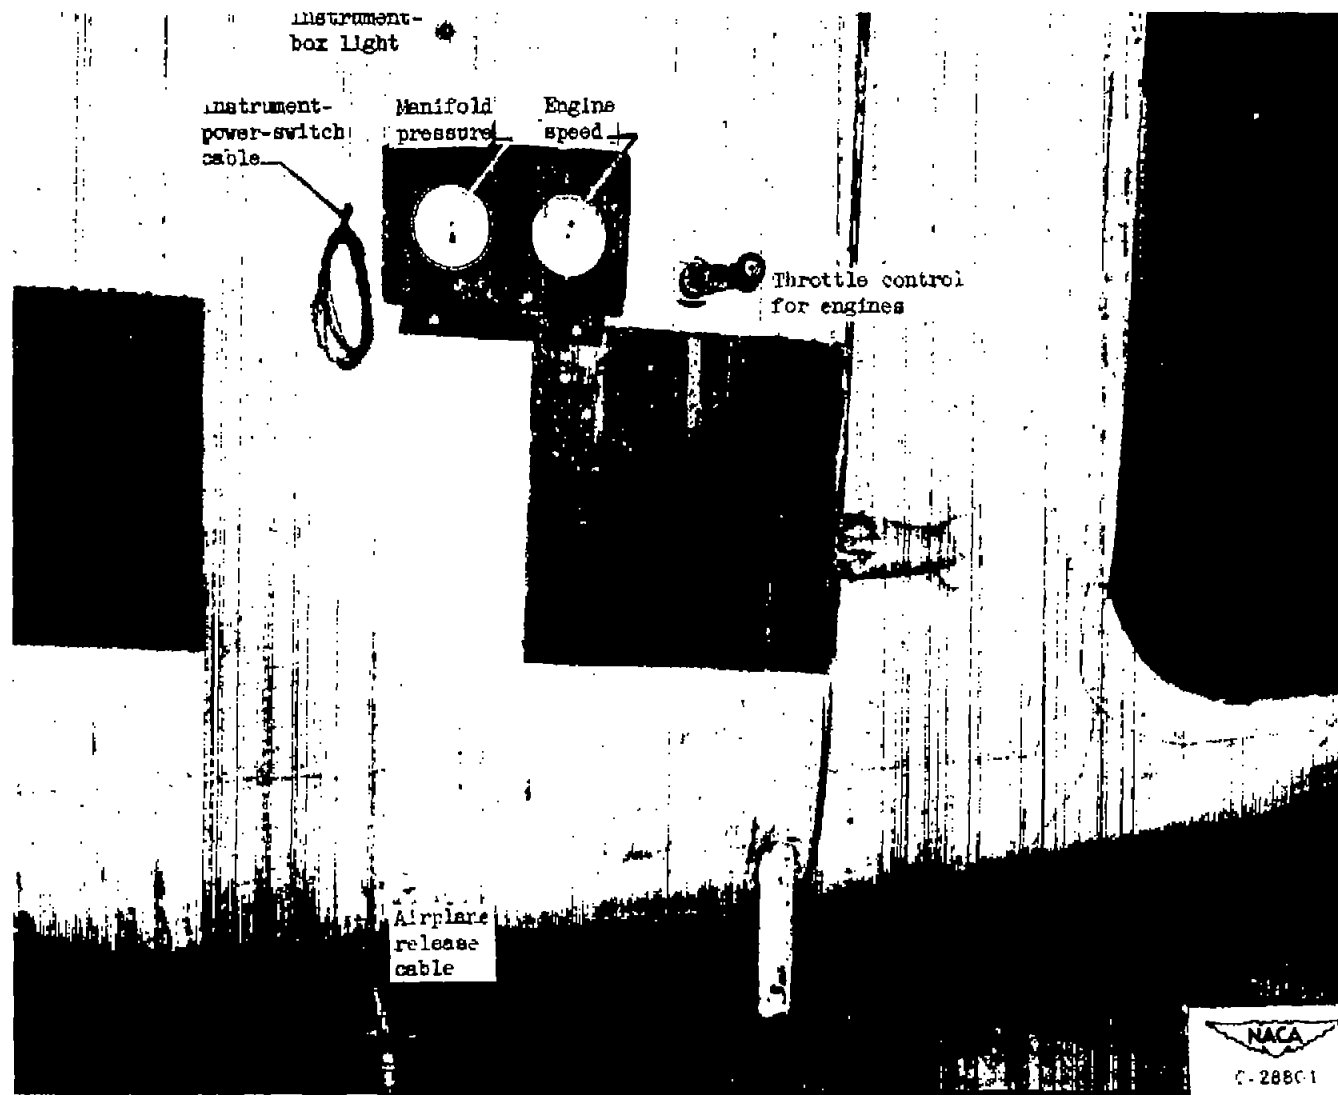
Figure 16. - Controls for operating engines, instrument box power, and airplane release located at rear of fuselage in C-82 airplane.

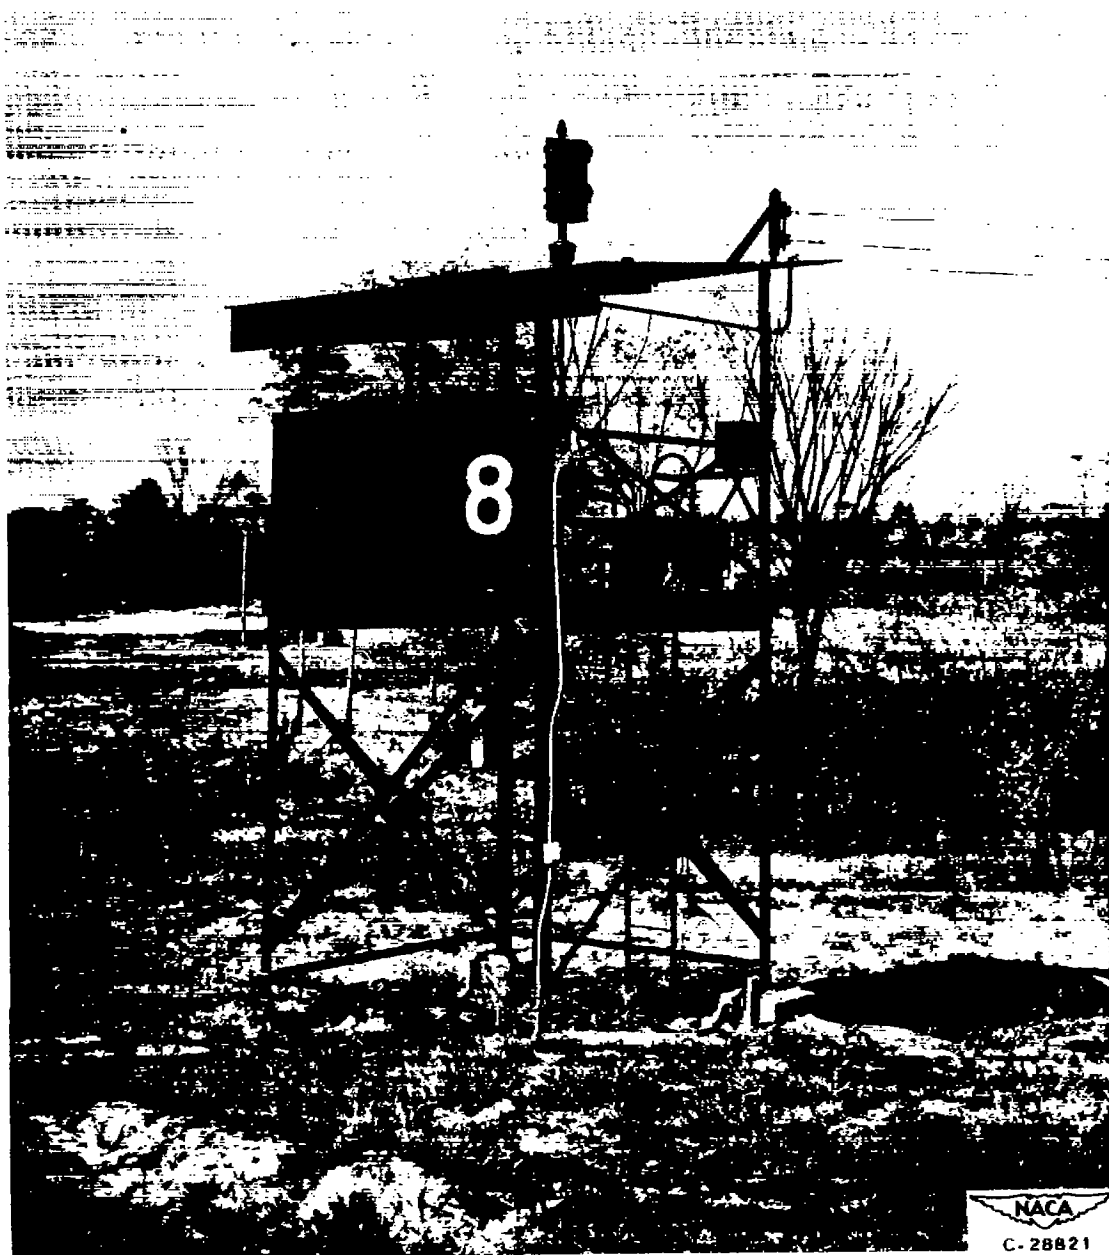
Figure 18. - Typical camera platform installation in crash area.

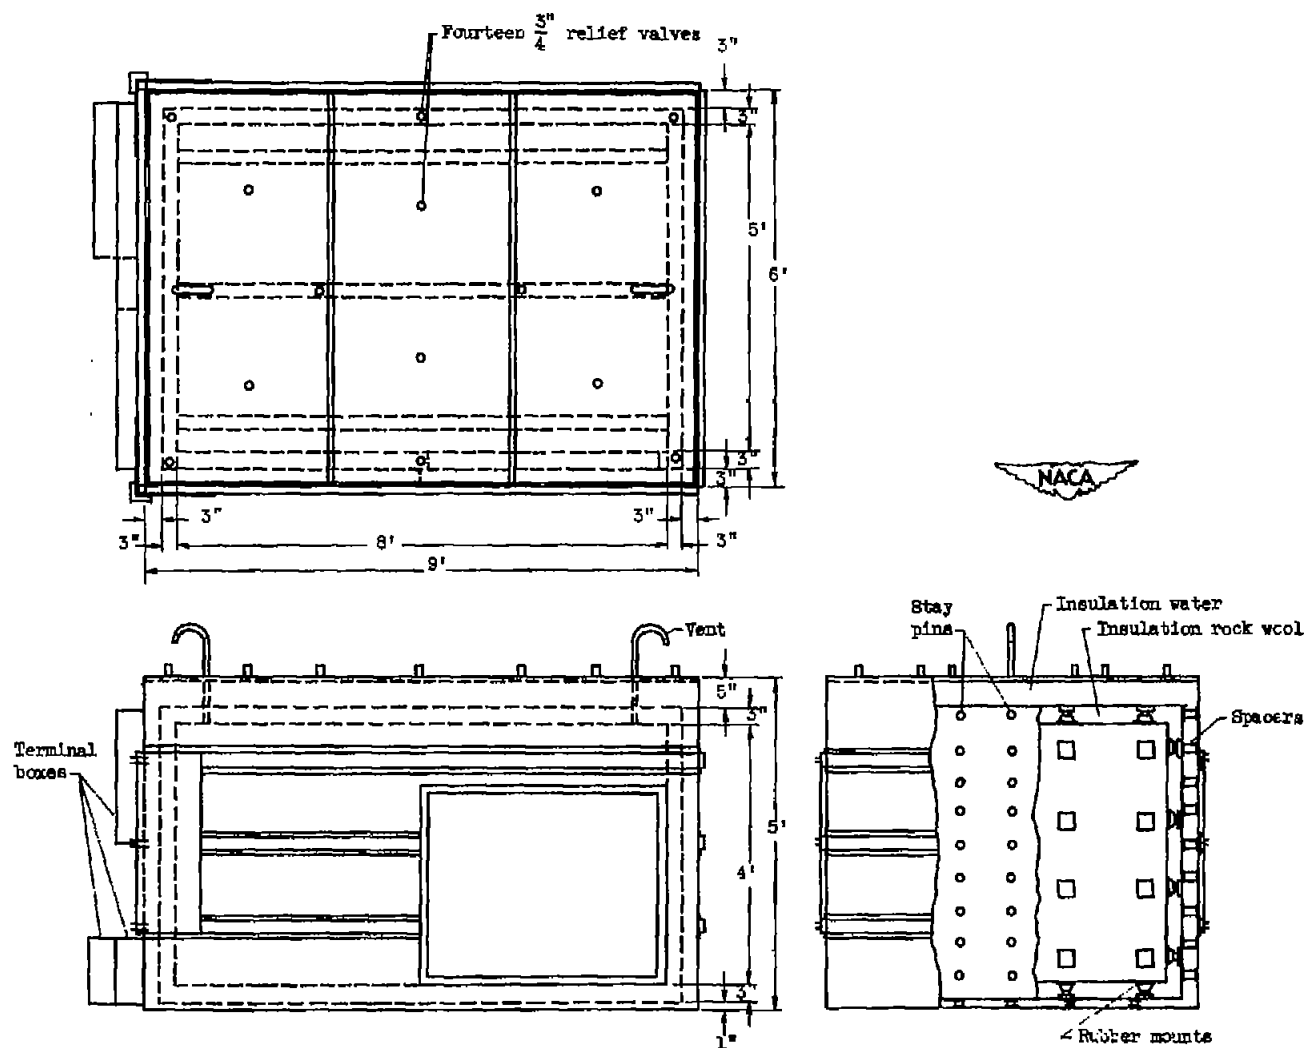
Figure 20. - Sketch showing construction of fireproof instrument box. Material, 1/16-inch black iron; water capacity, 310 gallons; total weight, 6675 pounds.

Fireproof instrument box. - It was necessary that the temperature inside the instrument box remain below 200° F in order to protect the motion-picture film in the cameras. A sketch of the fireproof instrument box showing the general dimensions and type of construction is presented in figure 20. The inside dimensions were: length, 8 feet; width, 5 feet; and height, 4 feet. The box was constructed of three 1/16-inch-thick black-iron boxes nested together with 3 inches of insulation between the inner and center boxes; 3 inches of water between the center and outer box walls with 1 inch and 5 inches of water on the bottom and the top, respectively. The inner box was shock mounted to the center box by rubber mounts to help absorb the shock of the crash. Figure 21 shows the construction of the instrument box before the top was installed. This view shows the space for insulation, water jacket, and rubber mounts. The instrument panel was mounted at one end of the box as shown in figure 22. Batteries for power, potentiometer, cameras, junction box, cabin-air sampling containers, and timer were located at the opposite end of the box as shown in figure 23; figure 24 is a close-up view showing the installation of the cameras, junction box, and timer for cabin-air sampling system.
